IMAGE ARTICLE

Pacemaker Lead Vegetation

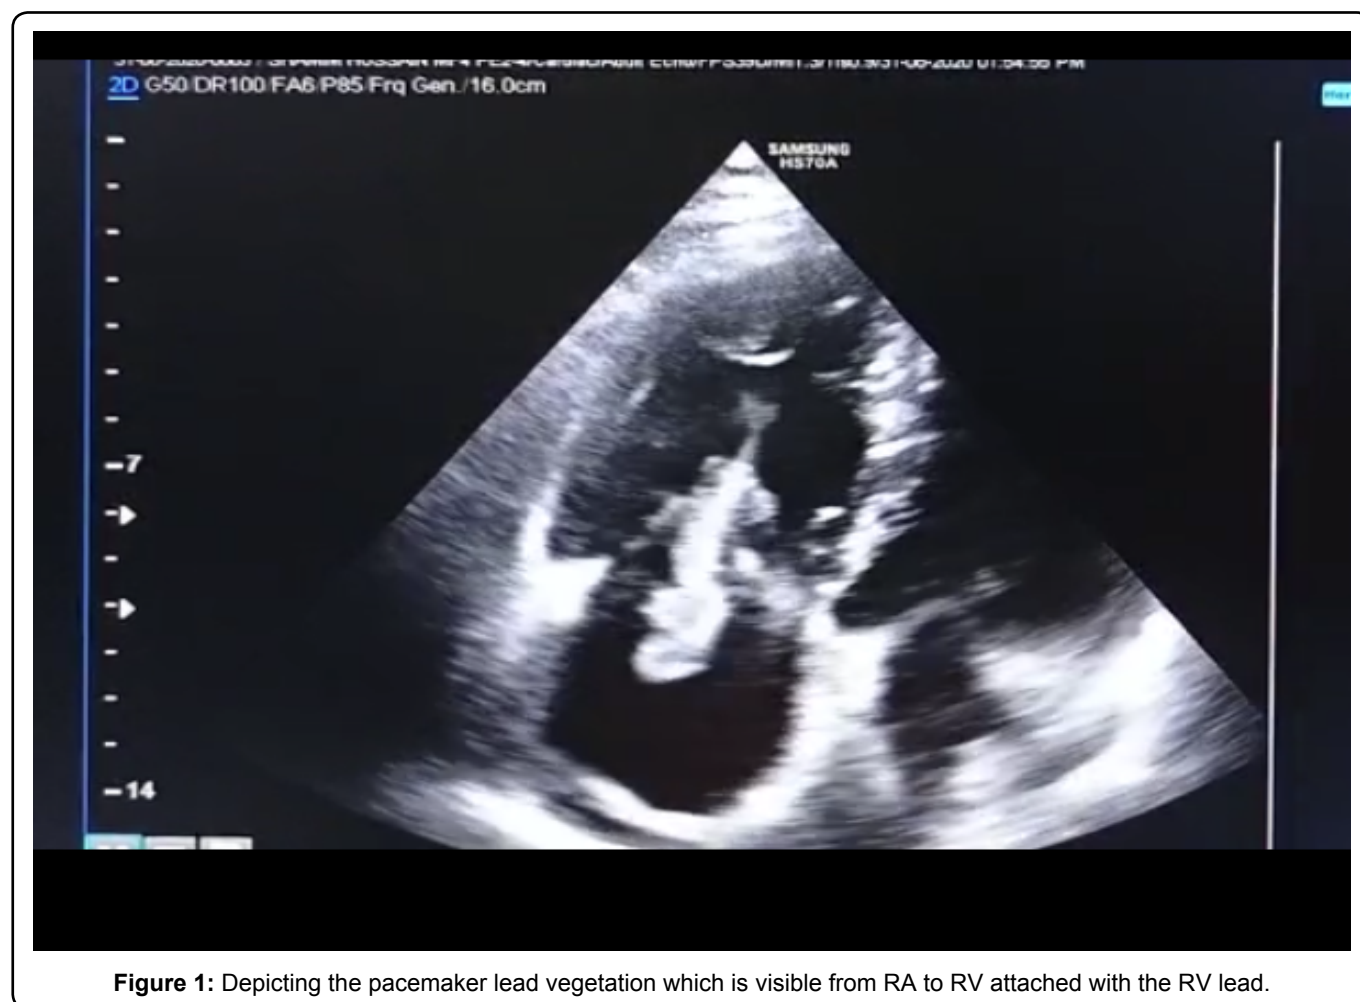
Figure 1: Depicting the pacemaker lead vegetation which is visible from RA to RV attached with the RV lead.

vealed echogenic structure attached to RV pacing lead and moving along with the lead from RA to RV (Figure 1 and Figure 2). Patient had severe tricuspid regurgitation which is evident in Video 1. Patient was admitted empirical antibiotics therapy started after sample of blood culture was sent. Reports of blood culture including fungal culture were negative. Although percutaneous extraction of pacemaker lead could be done but considering the size, tethered nature of vegetation, fibrosis of the lead due to long history of pacemaker she was transferred to department of Cardiothoracic surgery for extraction of lead. Figure 1 and Figure 2 depicting the pacemaker lead vegetation which is visible from RA to RV attached with the RV lead and moving along with it. Tricuspid valve leaflet was free from any attachment to vegetation. Video 1 showing the vegetation mass along with severe tricuspid regurgitation and dilate RA.

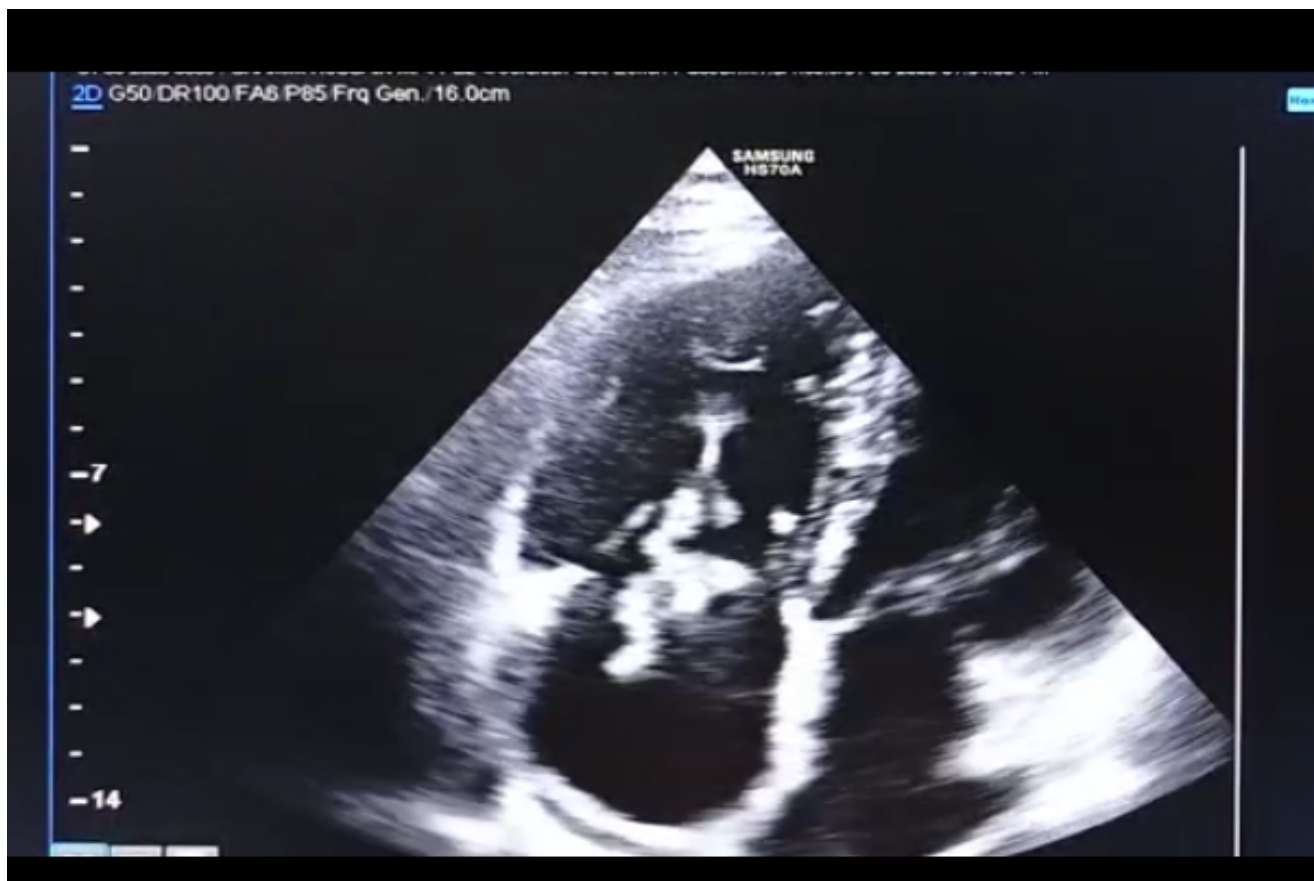
Figure 2: Showing the vegetation attached to RV lead and septal leaflet is free along with dilated RA.
