## REVIEW ARTICLE

# Penile Prosthesis Surgery in Italy: Personal Experiences, Complications and Considerations after 552 Cases

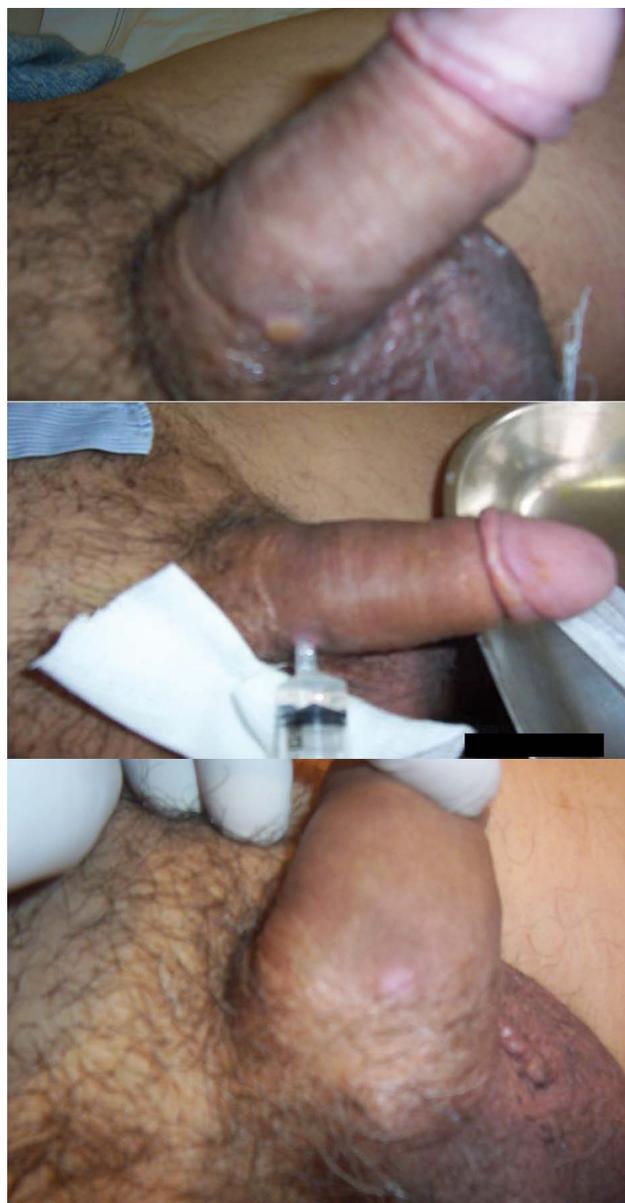
**Figure 1:** Cutaneous fistula with purulent secretion 15 days after IPP; Local infusion of iodopovidone and Gentamicin solution; Closure of the fistula after 20 days of medical treatment.

-In 2004, a 58 years old patient with vascular ED, received an AMS700 Ultrex IPP. Usual pre- and postoperative antibiotic therapy. After 2 weeks, before

the implant had been used, the patient complained of pain at the base of the penis, septic fever and a yellowish boil at the base of the penis on the right, with a yellowish creamy purulent secretion (Figure 1). If we inflated the cylinders the volume of pus increased. Due to the purulent infection, it was suggested to the patient that the implant should be removed. The patient, mainly for economic reasons, refused categorically. We began with a local injection of a solution of iodopovidone and Gentamicin, 2-3 times a day, with deflated cylinders, followed by the partial inflation of prosthetic cylinders in order to wash and evacuate the infected cavernosal fluid. We repeated the procedure every 8-12 hours for 7 days. A progressive reduction in the volume and purulence of the secretion was recorded. For 3 days Gentamicin alone was injected into the fistula, followed by the complete deflation of the implant cylinders. The opening closed after 20 days. We maintained the

cylinders at maximum inflation. No secretion, pain or fever was observed for 4 days with the deflated cylinders. The patient did not complain further infections and maintained and utilized the implant regularly from 2004 to the last control in 2012.

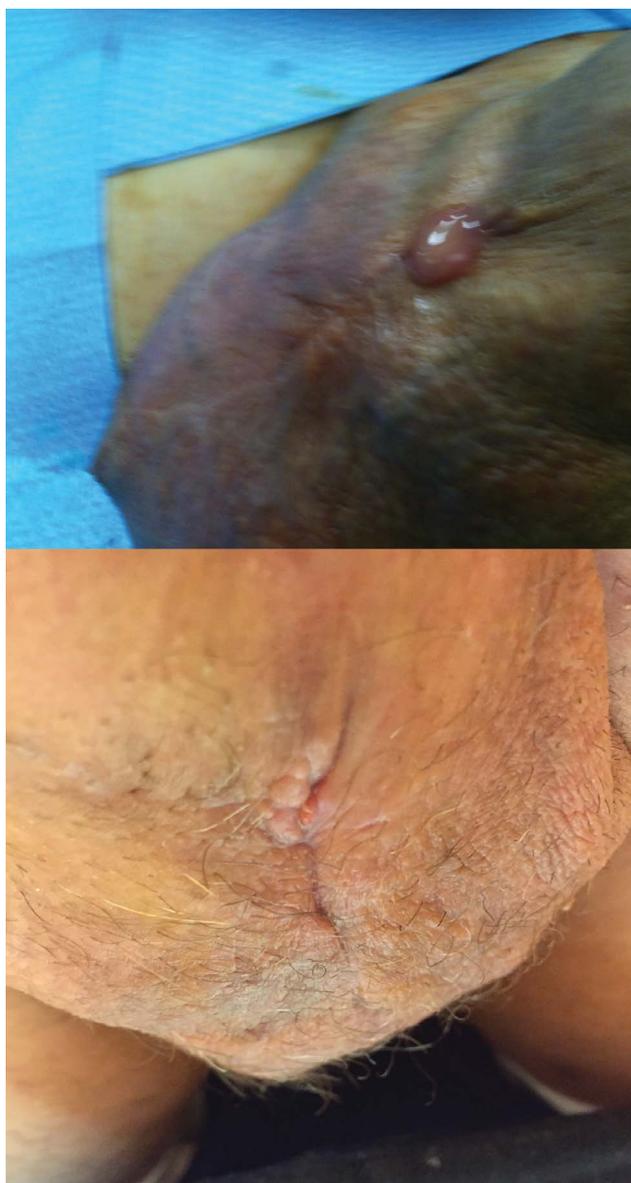
**Figure 2:** Purulent secretion from penoscrotal incision; After 7 days of local infusion of Gentamicin solution.

-In 2004, a 72 years old patient, diabetic, due to complete ED received an AMS700 Ultrex with a penoscrotal incision. After 2 years, in 2006, the patient started reporting fever, scrotal pain and leakage of purulent material from the old penoscrotal scar. We predicted the removal, but we began to inject Iodopovidone solution and Gentamicin into the scrotal wound twice a day for 7 days, in addition to a general therapy with Ciprofloxacin and Ceftriaxone. The leakage of purulent material stopped, and the wound healed (Figure 2). After 15 days, the patient began using the pump and the prosthesis again. Since then, IPP works regularly.

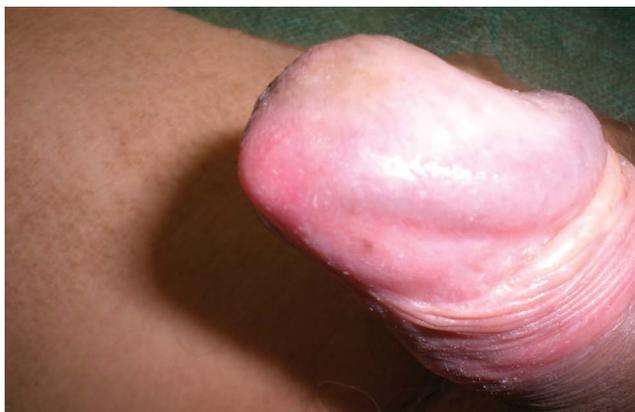
**Figure 7:** Partial extrusion of the Tip of AMS700: No infection.

A 56 years old patient, with Peyronie's disease and ED, underwent AMS700 CX implantation. Two cylinders 18 cm long with +2.0 cm RTE were inserted. After 6 months the patient complained pain in the glans, which appeared deformed, due to suspected apical extrusion of the right cylinder (Figure 7). It was decided to perform exploratory surgery. This involved subcoronal in-

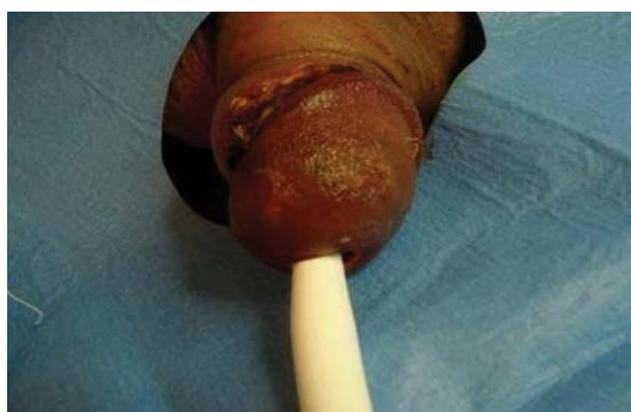
**Figure 9:** Extrusion of a malleable cylinder.

In a 36 years old patient with diabetes and CVOD, Implantal PP120 silicone rods were implanted in 2003. After 6 years he started complaining of pain in the glans, associated to the feeling of a lump on the left side of the penis. Surgery was performed to free the tip of the corpus cavernosum perforated by the cylinder, which was extracted, and the area was flushed with antibiotics. It was decided not to implant a new cylinder immediately due to the fear of infection. After discharge, the patient reported acceptable sexual relations with just one cylinder and preferred not to undergo further surgery (Figure 9).

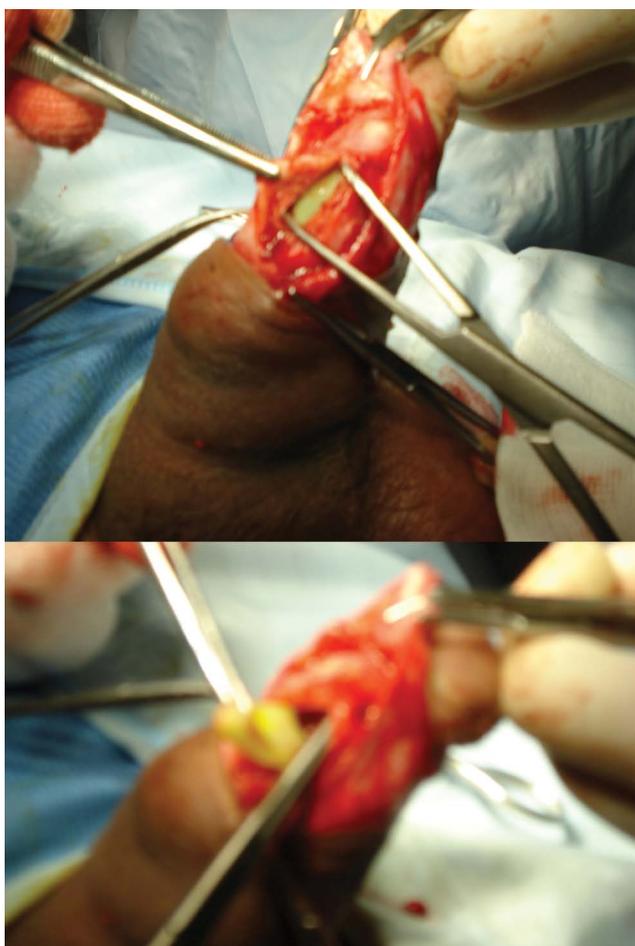
**Figure 8:** Distal incision to remove the cylinder.

cision, isolation of the glans to check the tip of the cavernous body which seemed to have been perforated by the cylinder. The cylinder was still inside the penis, and therefore there was no reason to suspect bacterial contamination. After incision of the right side of the penis and of the tunica albuginea, (Figure 8) the right cylinder was extracted and the 2.0 cm RTE was replaced with a 1.0 cm RTE. We affixed as a “hood” a small Marlex patch for hernia repair. The right cavernous cylinder was reinserted. After verifying that there was no apical tension, the glans was fixed above the tip of the corpus cavernosum. The cylinders were kept inflated for 5 days and

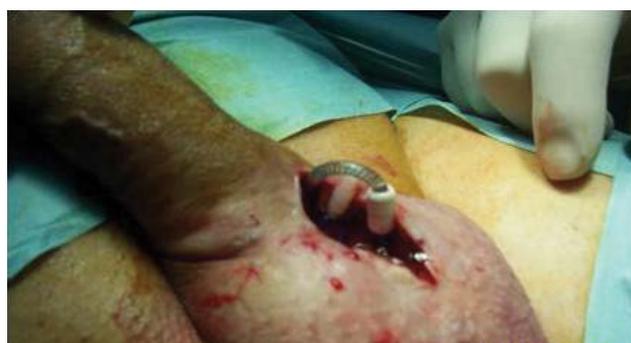
**Figure 10:** Scrotal skin perforation due to scrotal tubing: Local surgery.

In a patient diabetic and hypertensive an AMS700 Ultrex IPP was implanted in 1999 with good sexual results till 2006 when he reported pain at the base of the penis with skin swelling and secretion of serous fluid. No fever. The Implant was correctly working. We perform a local surgical treatment. A small skin lozenge around the tube was removed (Figure 10). The skin was sutured over the buried tube. We didn't recorded any local complication and the patient, after one month, was allowed to utilize the IPP.

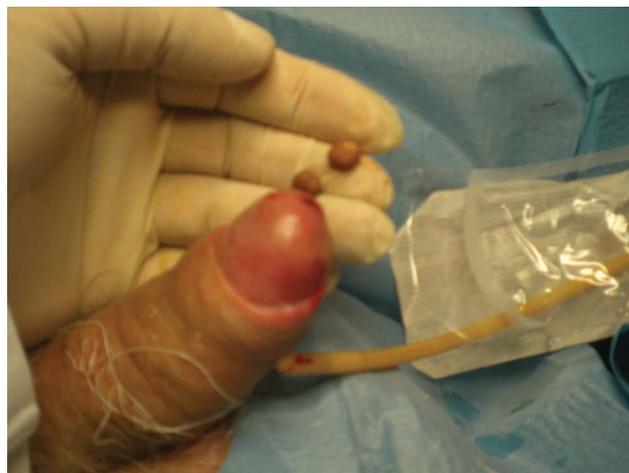
**Figure 12:** Two urethral stones removed 9 years after an IPP.

meatotomy and two stones, of 5-7 mm diameter, were extracted (Figure 12). We inserted a Foley CH16 catheter without encountering any obstructions. Short antibiotic cycle of Ciprofloxacin for 5 days and the patient was submitted to flexible cystoscopy with no urethral strictures, prostatic hyperplasia, detrusor hypertrophy and no bladder stones.

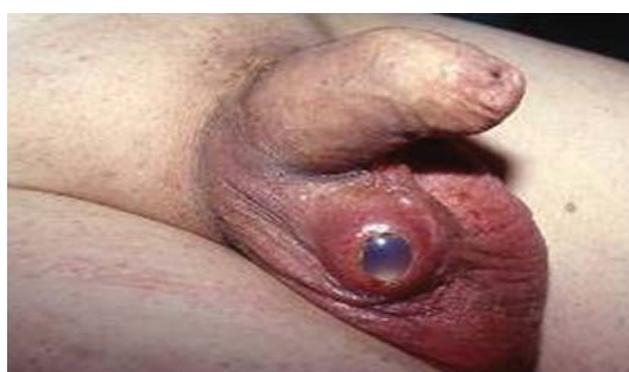
**Figure 13:** Purulent scrotal skin erosion due to scrotal abscess in diabetic patient 36 days after IPP: Removal of all the system.

In 2 diabetic patients, 58 and 64 years old, with AMS700 Ultrex IPP, after 30 and 36 days we recorded scrotal pain, inflammation, skin erosion and purulent reaction. In few days the prosthetic pumps emerged outside the scrotal skin (Figure 13). We decide to explant the IPPs. Neither patient wanted to undergo a new implantation procedure, due in part to financial motives.

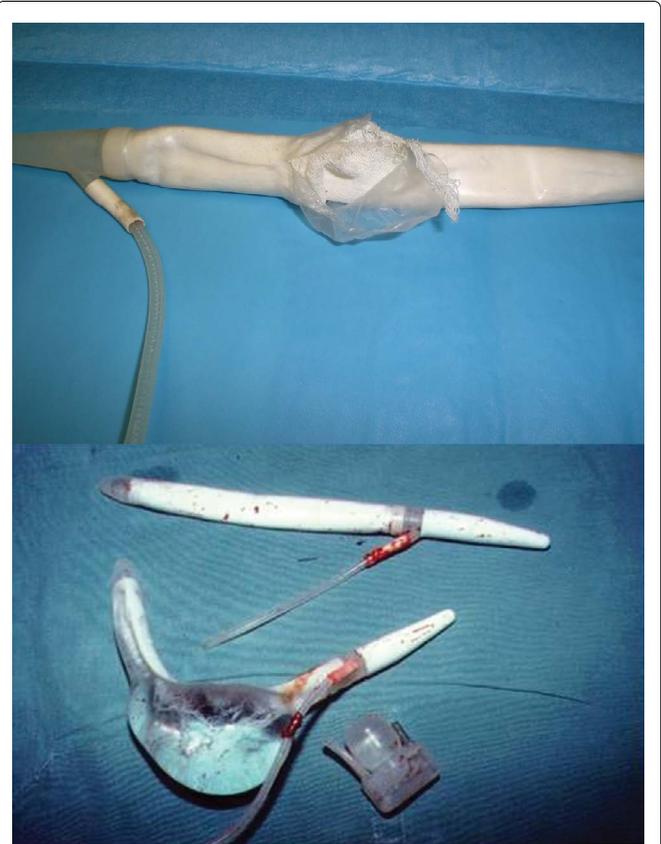
**Figure 14:** Rupture of the outer sleeve of AMS700 Ultrex after 5 Years; Aneurysmatic dilatation of AMS700 Ultrex cylinder after 3 years.

The risks of malfunction, breakage or breakdown of the implant itself represent another limitation of PPS. After 15 years an IPP is likely to develop a problem (Figure 14). The lifetime guarantee offered by the manufacturers somewhat attenuates the annoyance of having to replace the implant but does not address the inconvenience and cost of the new procedure itself.
