## CASE REPORT

# When Equipment Misbehaves: Severe Respiratory Acidosis Resulting from a Compromised Coaxial Circuit

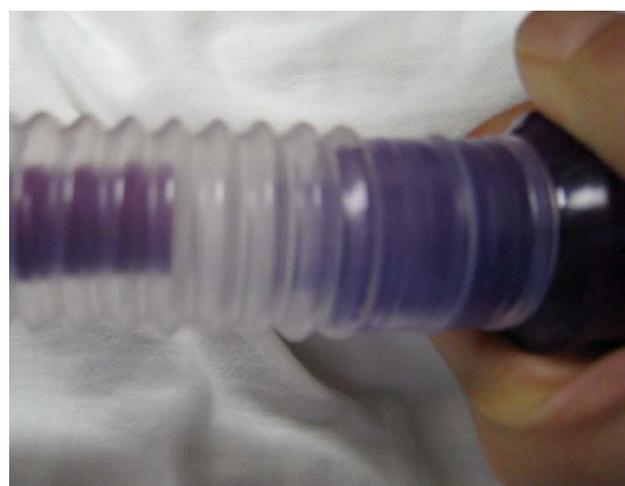
**Figure 1:** Actual defective co-axial circuit extension discovered intraoperatively. The disconnection in the central inspiratory limb is more visible with stretching and flexion of the circuit.

To allow for closer inspection of each circuit component, the neuro-anesthesiologists detached the entire circuit from the patient and ventilated the patient with a bag valve mask. To assess the integrity of the inner tube, the providers applied lateral force to the circuit, flexing each extension at its base to make any defect more visible. Two breaks in the central inspiratory limb of the distal extensions were found. Both extensions were replaced, after which the patient's capnogram normalized. The ETCO<sub>2</sub> reading also began to trend downward, quickly normalizing to baseline values in the mid-20 s.

Ultimately, what the providers found was a disconnection in the central inner tube of the coaxial breathing circuit that resulted in rebreathing of expired gases and severe respiratory acidosis. The lateral force or stretching of the coaxial tube when the patient was moved into the MRI scanner for the intraoperative scan likely caused the tube to disconnect. The disconnection was difficult to detect because of its location within the inner coaxial tube and subtle appearance. In fact, the disconnection only became obvious when the providers actively applied lateral force to the circuit, bending it at its base in order to expose the defect (Figure 1). Consequently, the displacement of the inspiratory limb compromised the integrity of the circle system and its ability to remove expired CO<sub>2</sub>.

viders assessed several new King circuits and found that nearly all of the inspiratory limbs of these circuits could be disconnected by applying lateral force. We speculate that exposure of the circuit to the heat and humidity of rebreathed gases during routine ventilation may have compromised the mastic holding the central inner tube intact. As a result, less force was needed to displace the central inner coaxial tube in this case. Thus, in this scenario, movement of the patient into the MRI scanner may have created enough lateral force to cause the circuit to become compromised.

Because the circuit was intact at the start of the surgery, it would have been difficult to prevent the subsequent disconnection of the central inner tube. However, anesthesia providers who are aware of the possibility of coaxial circuit failures associated with the inspiratory limb will be in a position to identify the problem early, thereby limiting the degree of respiratory acidosis that develops and reducing the risk of associated complications. However, other potential causes of rebreathing of CO<sub>2</sub> to consider include malfunctioning valves, depleted CO<sub>2</sub> absorbent, and excessive gas channeling through the absorbent. We recommend visually inspecting the circuit as part of the routine machine and equipment check during anesthetic preparation and in the event of any derangement of physiologic parameters intra-operatively. In compliance with FDA requirements, the providers contacted the manufacturer and recommend
