Role of MARS Protocol of MRI in Patellar Clunk Syndrome and Fracture of Post of Polyethylene Liner: A Case Report

We report a clinical case of a 65-year-old Male of Indian origin with Bilateral Patellar Clunk Syndrome along with fracture of post of Polyethylene Liner of right as well as Left knee.

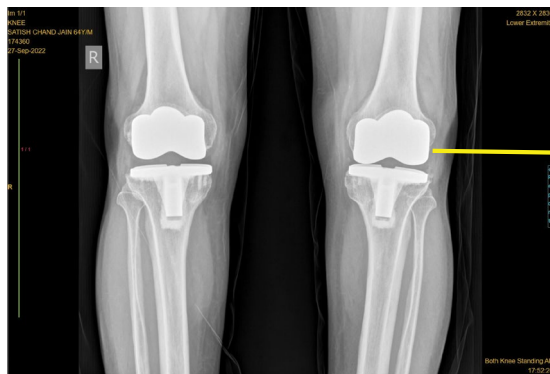
Figure 3: Anterolateral view (Both knees).

PS type implant

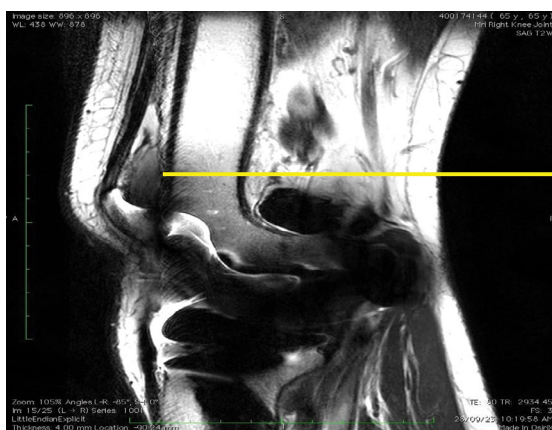
Figure 4: MRI (Right knee, Sagittal view).

Sagittal T2W images of right knee joint shows presence of isointense to hypointense soft tissue nodularity in suprapatellar compartment posterior to the tendon of quadriceps major muscle

In our case MRI was done and size of soft tissue masses proximal to the patella were determined in sagittal and axial MRI views (Figure 4, Figure 5, Figure 6 and Figure 7). The nodule tissue was characteristically of intermediate signal intensity on the moderate echo time pulse sequence, characteristic of synovial scarring. A correlation ultrasound (Figure 8) was also undertaken and the soft tissue nodule was observed in suprapatellar region. Both MRI and ultrasound findings in our case

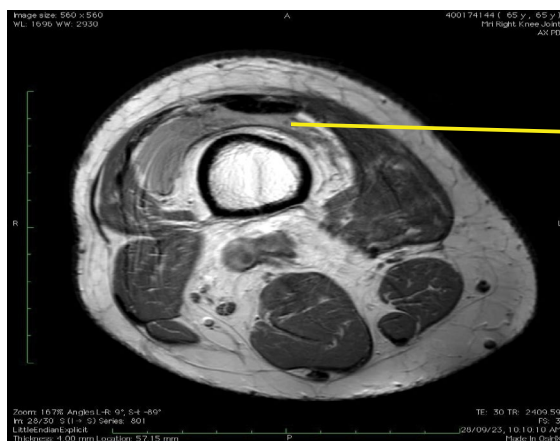
Figure 5: MRI (Right knee, Axial view).

Axial T2W images of right knee joint shows presence of isointense to hypointense soft tissue nodularity in suprapatellar compartment posterior to the tendon of quadriceps major muscle

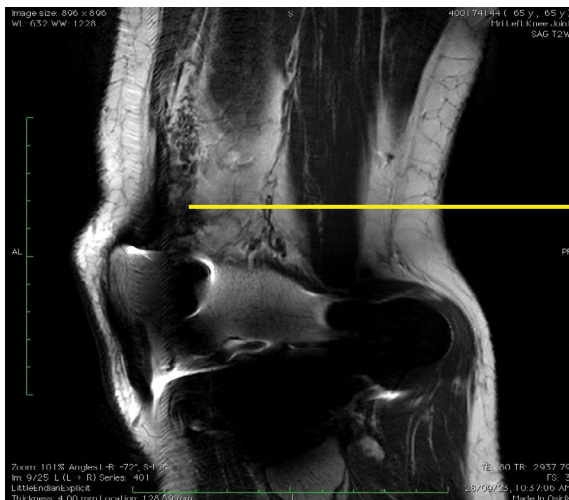
Figure 6: MRI (Left knee, Sagittal view).

Sagittal T2W images of left knee joint shows presence of isointense to hypointense soft tissue nodularity in suprapatellar compartment posterior to the tendon of quadriceps major muscle

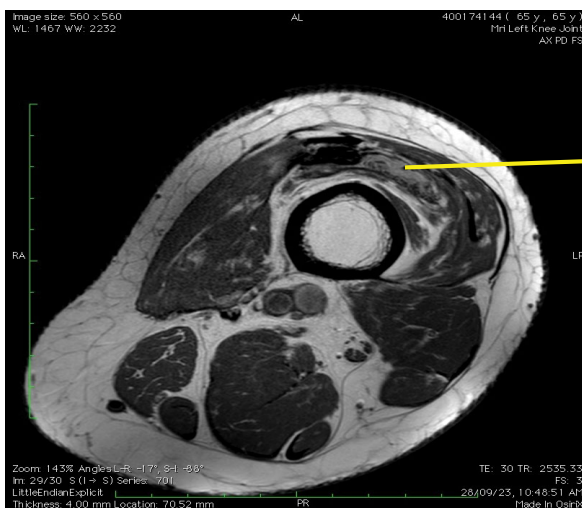
Figure 7: MRI (Left knee, Axial view).

Axial T2W images of left knee joint shows presence of isointense to hypointense soft tissue nodularity in suprapatellar compartment posterior to the tendon of quadriceps major muscle

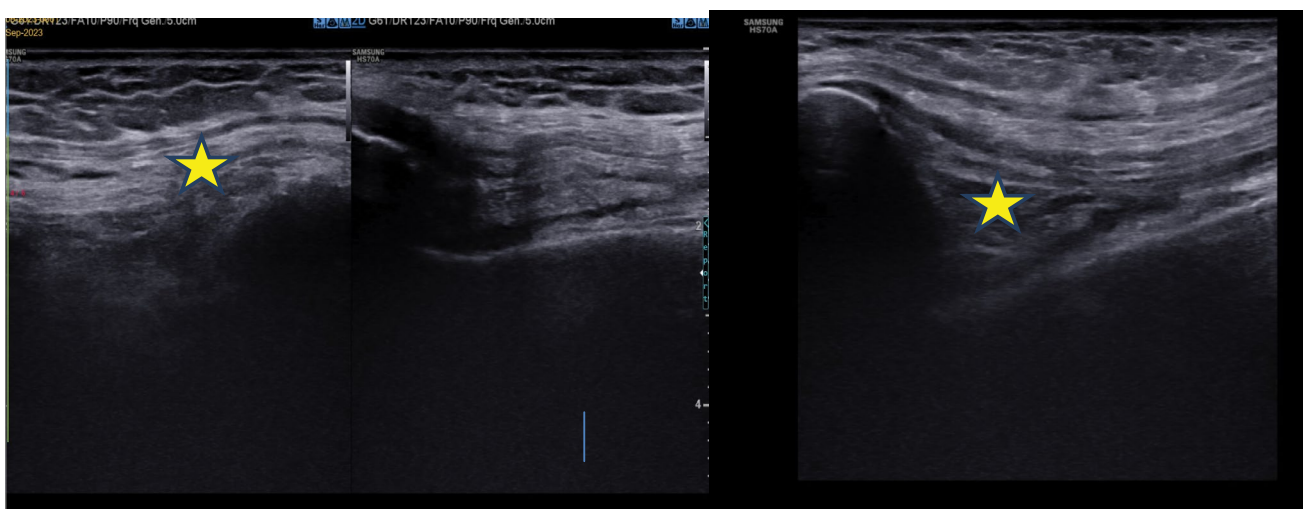
Figure 8: Ultrasound B/L knee joint shows presence of irregular hypoechoic soft tissue component in suprapatellar compartment posterior to quadriceps tendon.

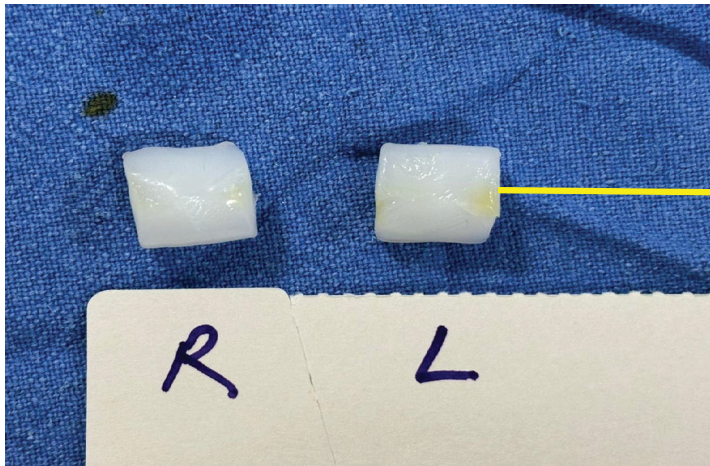
Post of polyethylene liner

Figure 9: Fracture cam post of polyethylene liner (Right, Left).

Once patient was diagnosed with PCS, he was taken for arthroscopic debridement where the surgeons also observed fracture of Post of Polyethylene liner (Figure 9 and Figure 10) along with PCS which was eventually removed.

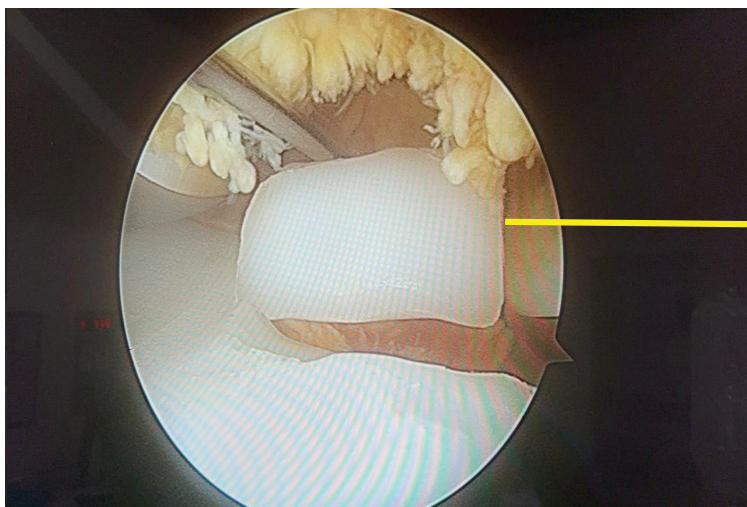
Post of polyethylene liner

Figure 10: Arthroscopic view of fracture cam post of polyethylene liner.

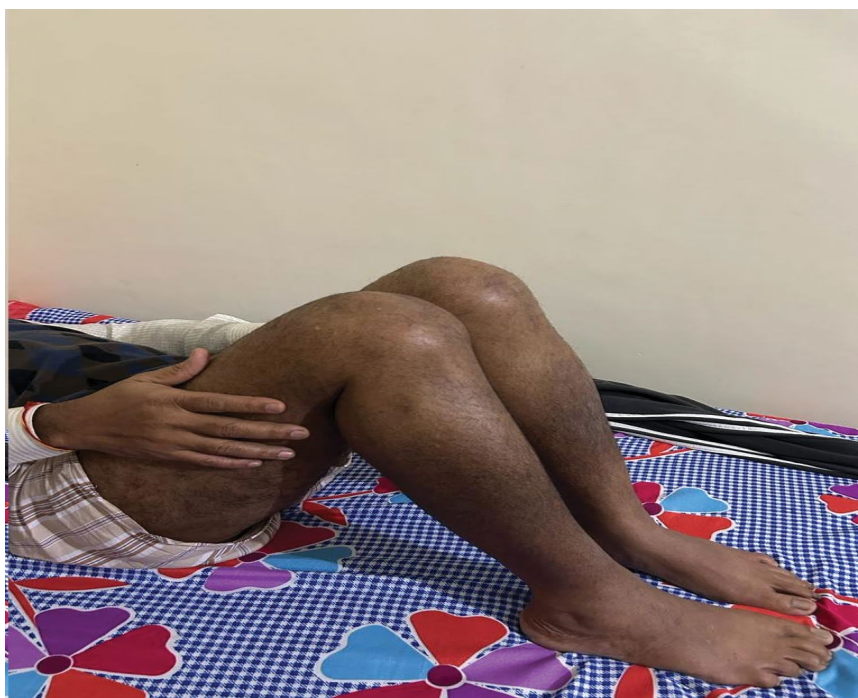
Figure 11: Range of motion (Right, Left).

arthroscopic debridement. Patient also achieved complete Range of Motion without any further clunk sound (Figure 11).
